## Status report

Adam Klekotko

09.11.2018

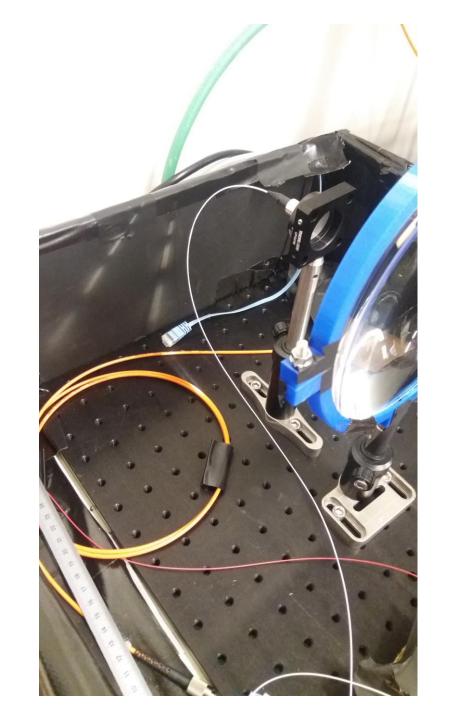
## Problems with uniformity

- To old setup I have added another fiber.
- We have to check if stream of light is really uniform.

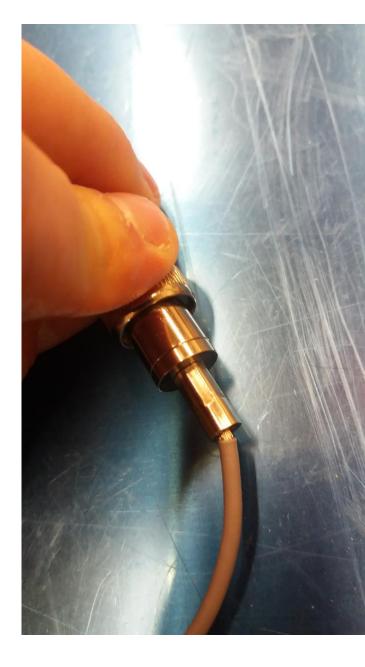
## Problems with PMT signal

- We have observed unexpected shape in charge profile
- We found a problem in a signal -> disruption
- After a few tests number of suspects is limited:
  - PMT basis HV cable is damaged
  - PMT (probably not)
