Status Report: at MEMPHYNO

Inomonoto, Sashima and Izumiyama 6 Mar. 2020 mPMT-Japan meeting

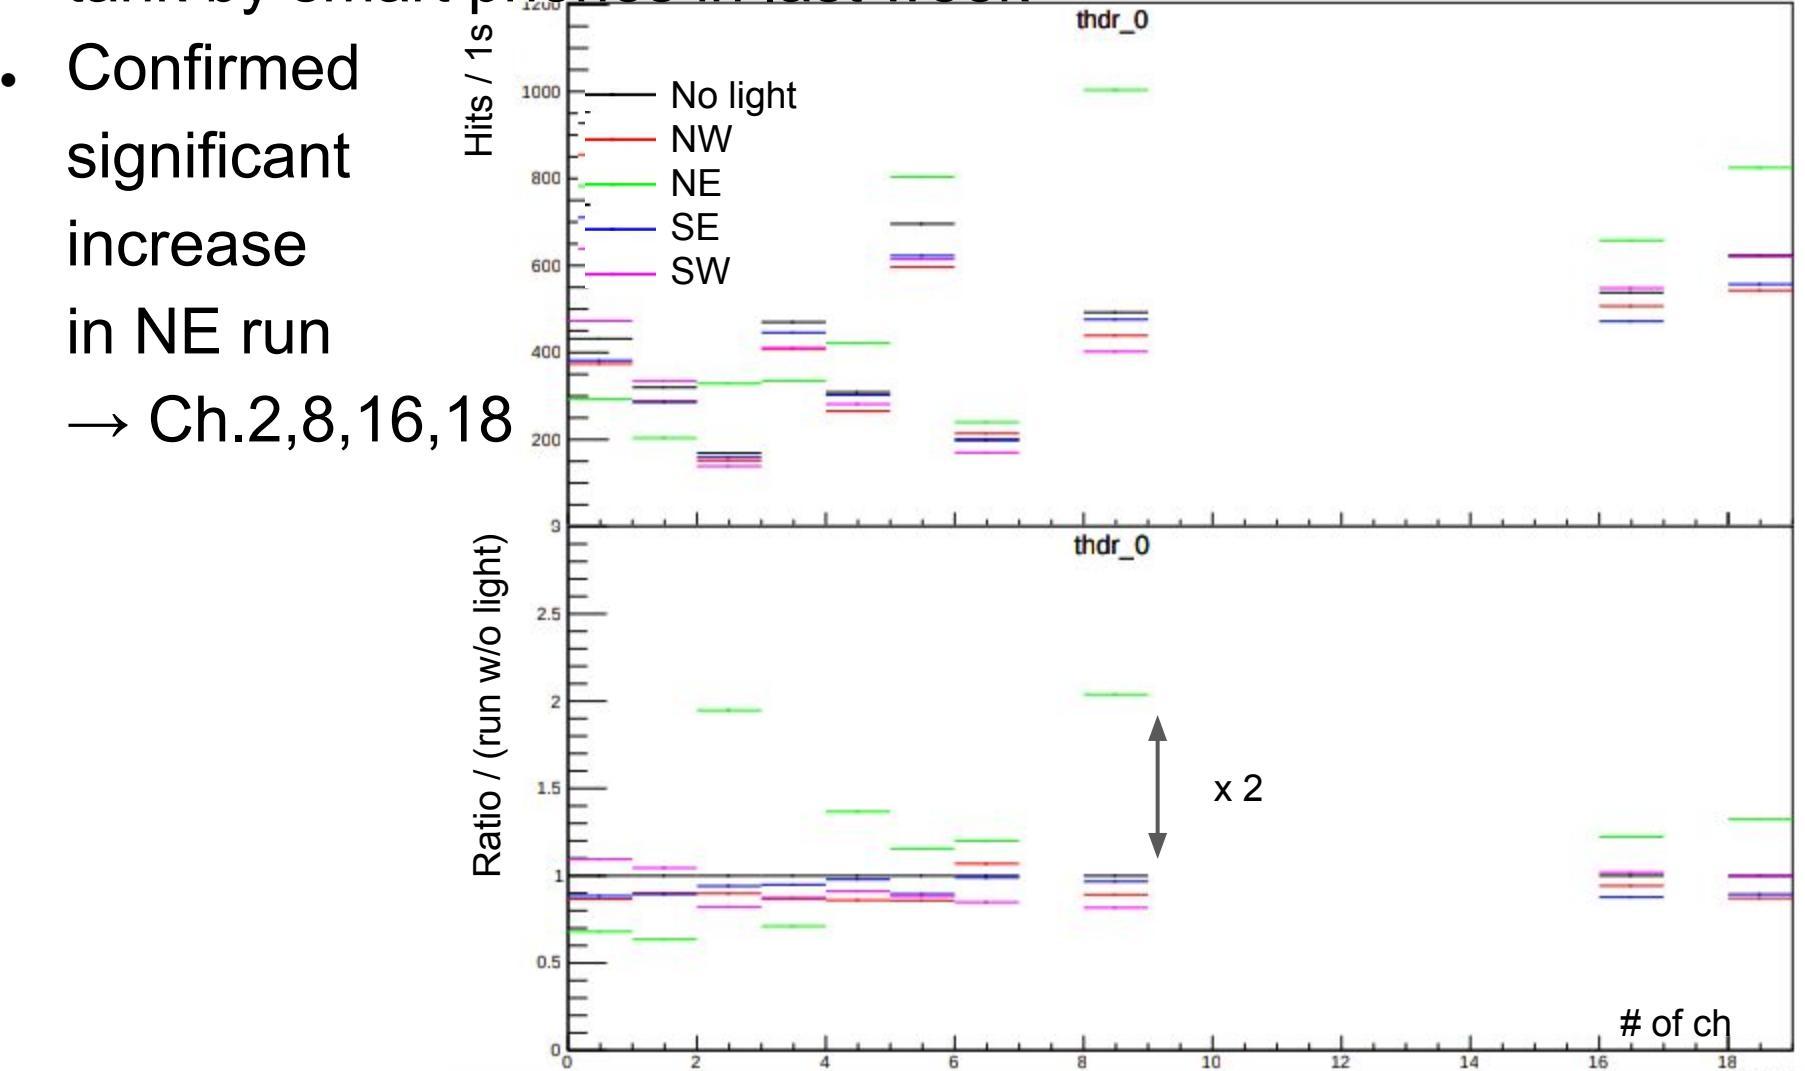
Investigation for leak points

Took the data with flashing light around the corner of the tank by smart phones in last week

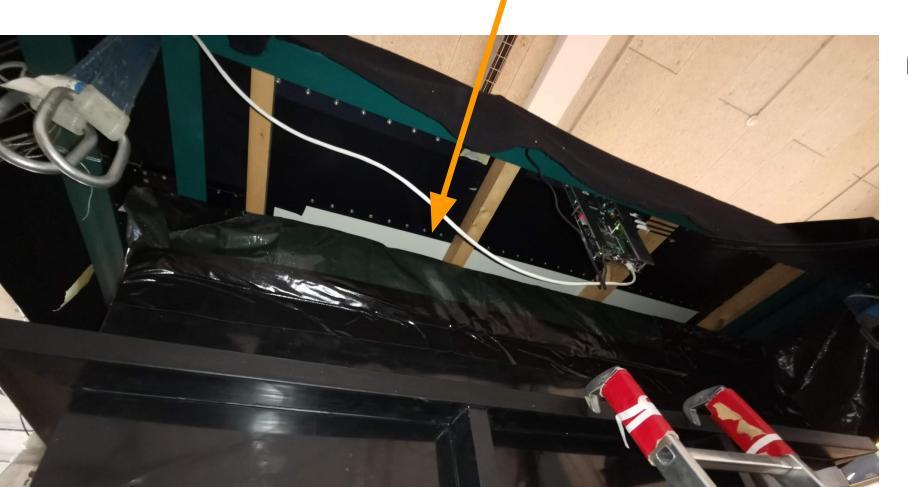
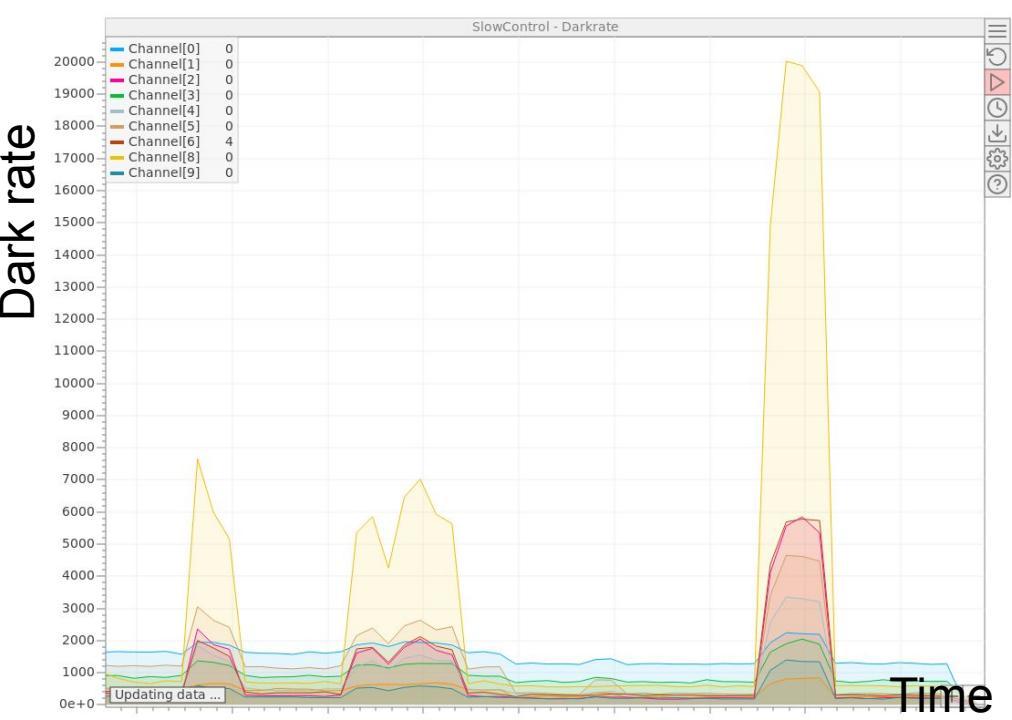
- Further investigation: spotlight of phones along the gap between top and side wall of the water tank
 - We confirmed the dark rate increased significantly (below spikes) for all ch.
- Reason: there are only one layer of the black tape for binding the gap \rightarrow not enough to block light
 - Need 4 or more layers of the black tape
- Added new 4 layers of the sheets of the tapes on all edge of the tank

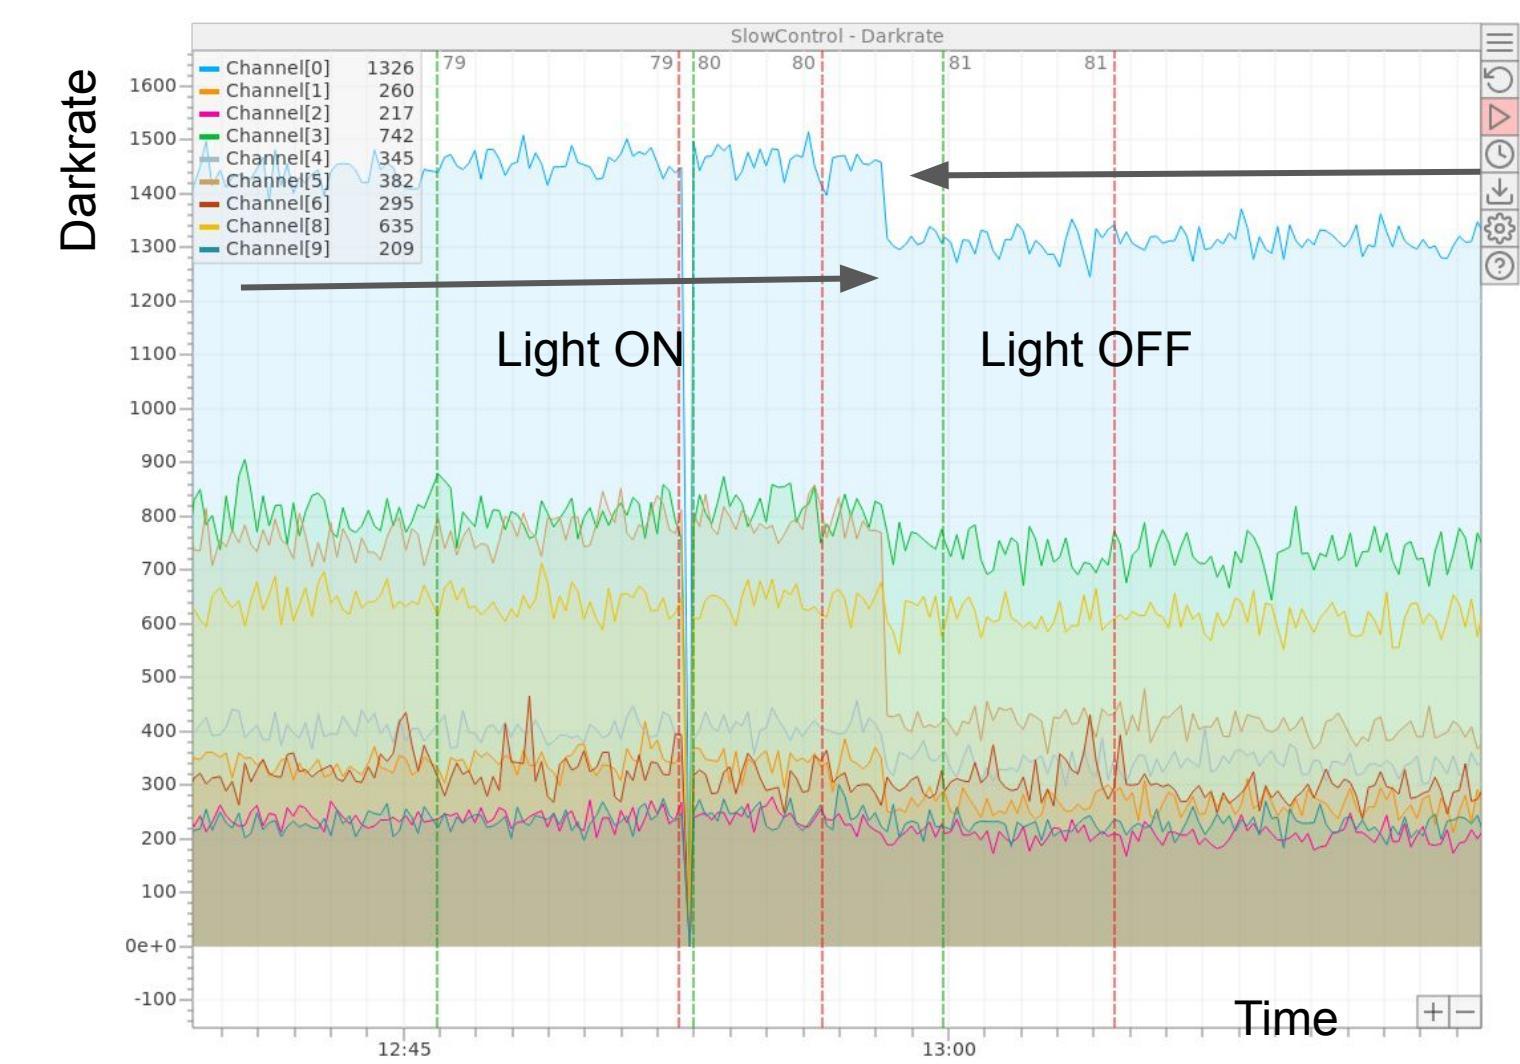
After second fix

• Some channels have been improved, but there are still the effect of light ON/OFF: blue, brown, green

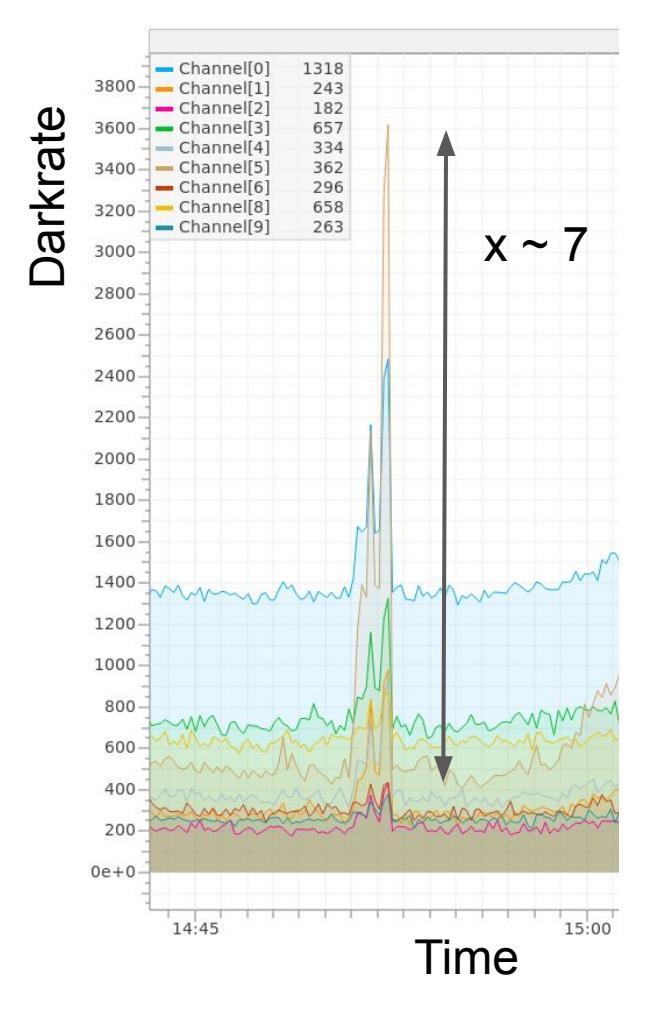
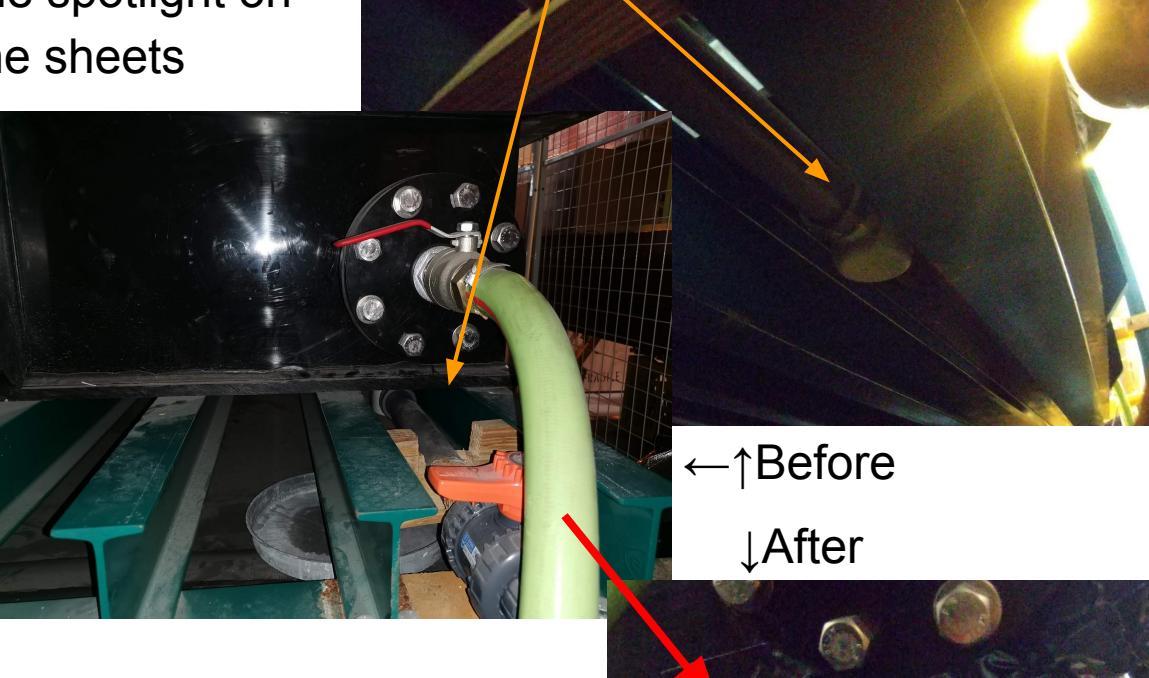
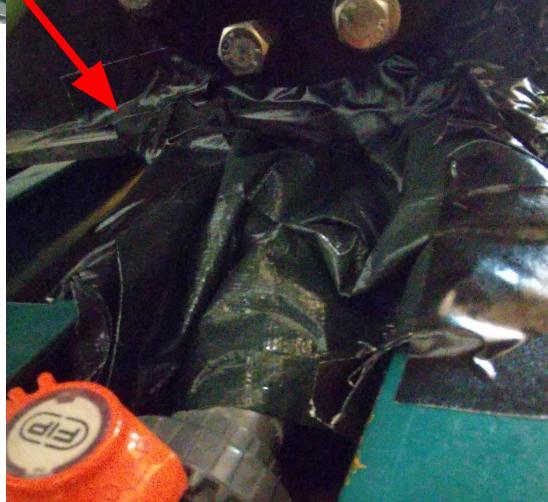
- · Found another leak point: a drainage pipe on the bottom
 - Saw spikes when turn the spotlight on
 - Covered the pipe with the sheets

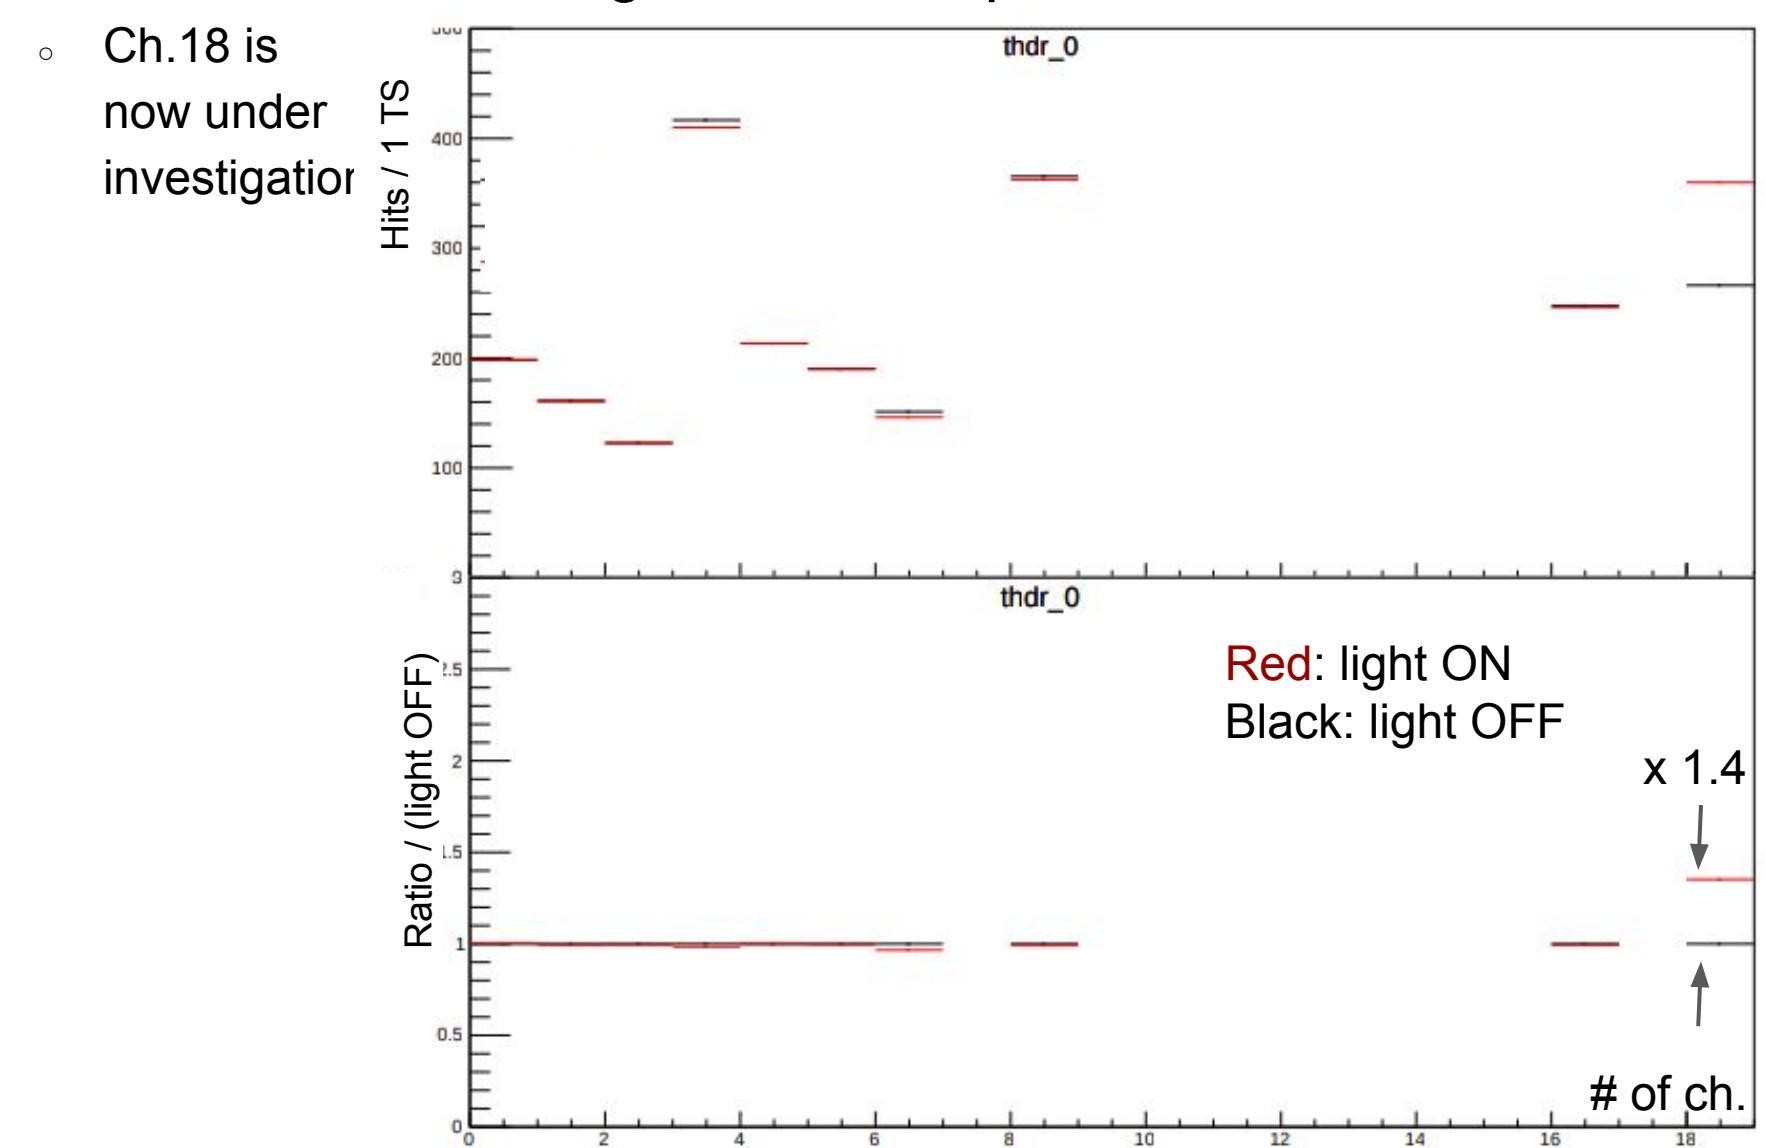
After all fix

• Succeeded to fix all light leak except for ch. 18

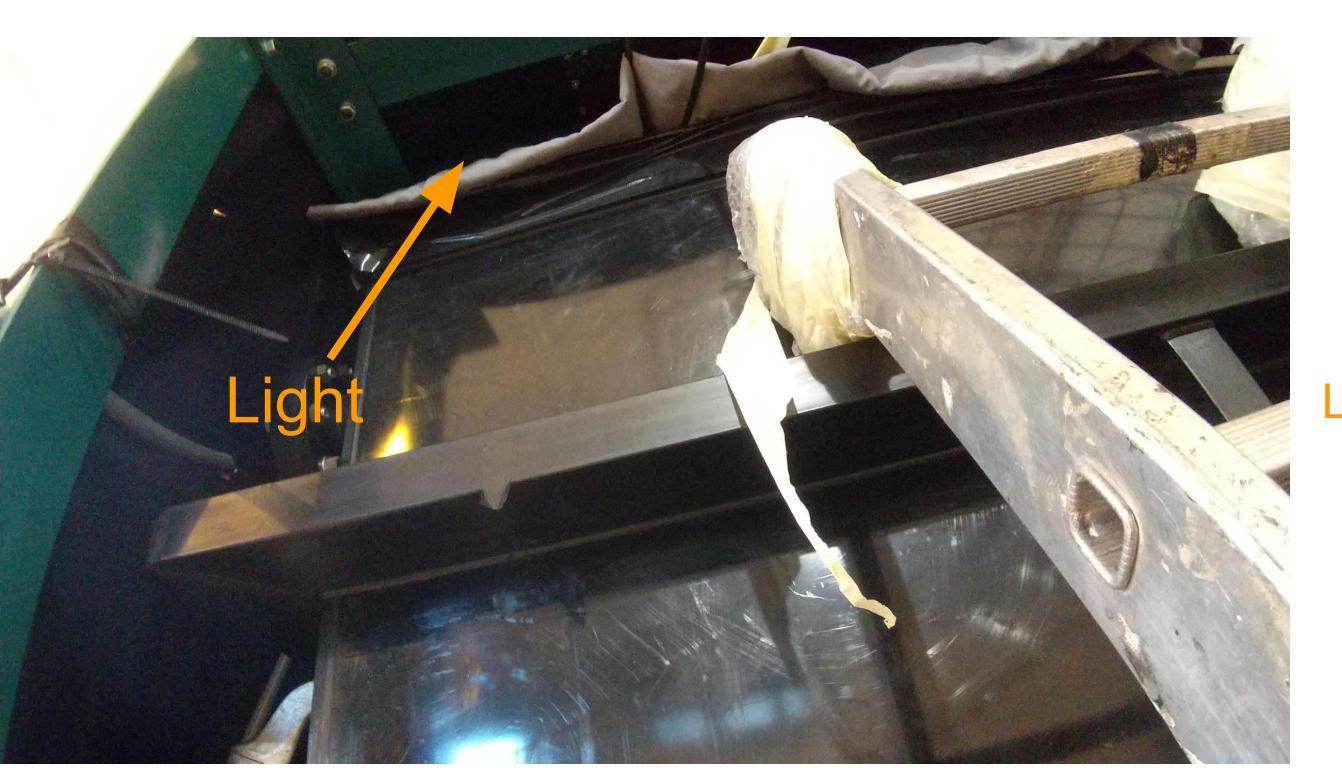
- At last HKPCM, the dark rate is correlated with day/night time → seems to be the light leakage
- Checking the light leakage point with light source.
 - Investigating the light leakage from the 4 corners of MEMPHYNO.
- Took the date, then we are analyzing it.
