# Status report

1/10/2020

# 3-inch PMT

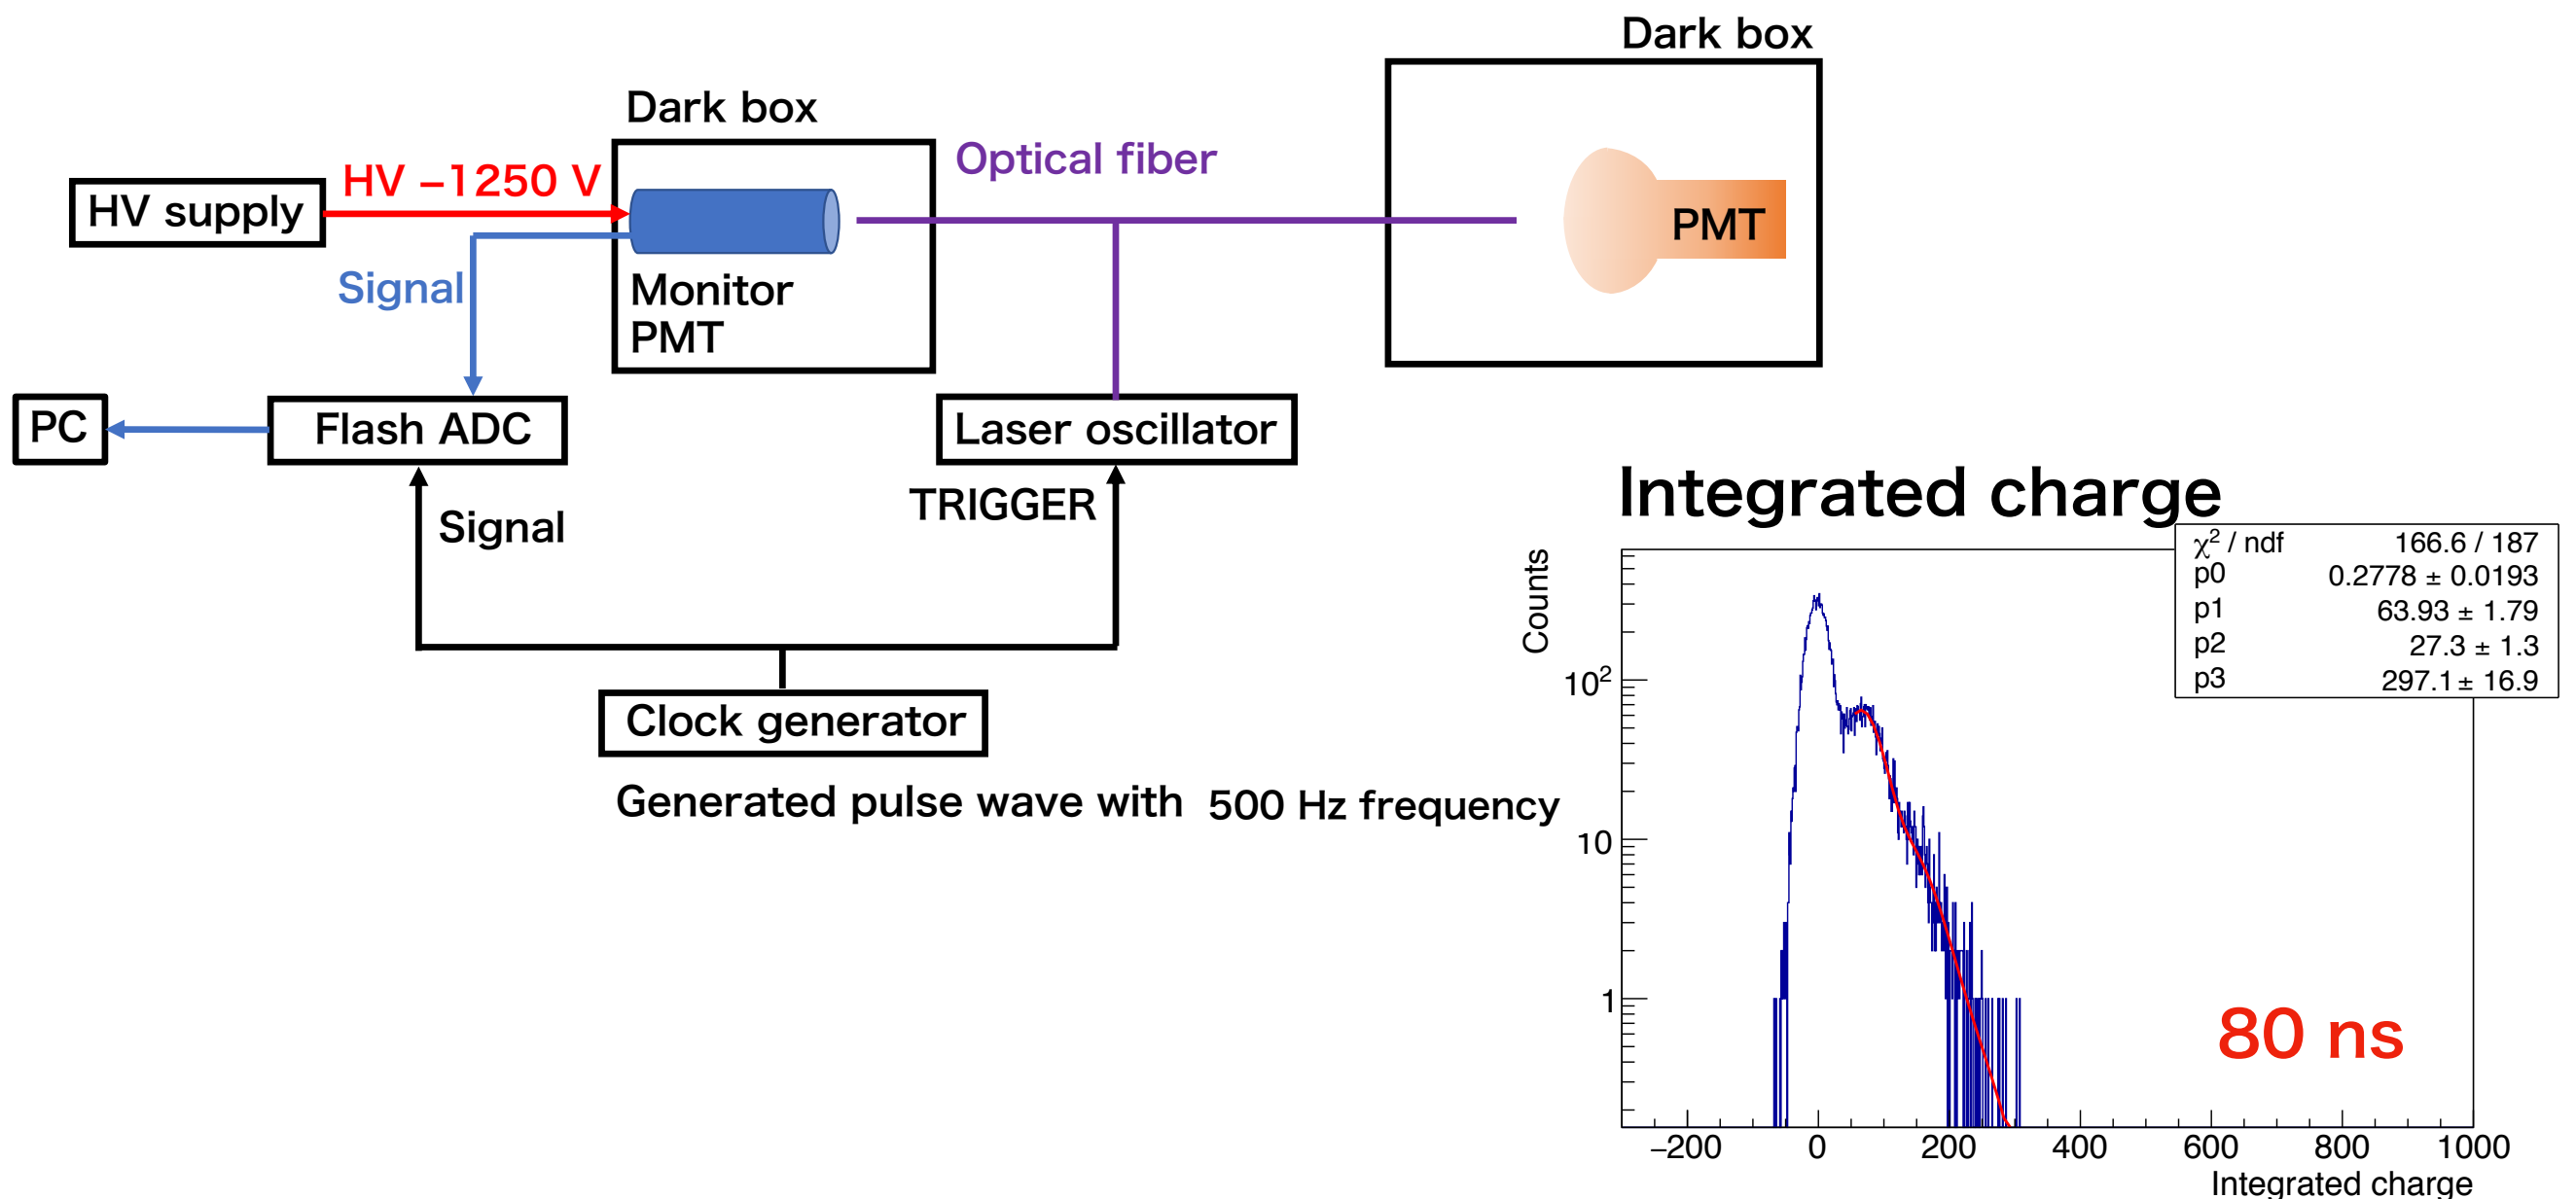
- I had measured the relative efficiency of 3-inch PMT.
- I calculated the integrated charge of 3-inch PMT.
  - The peak of 1 p.e. was not clear to analyze the signals.

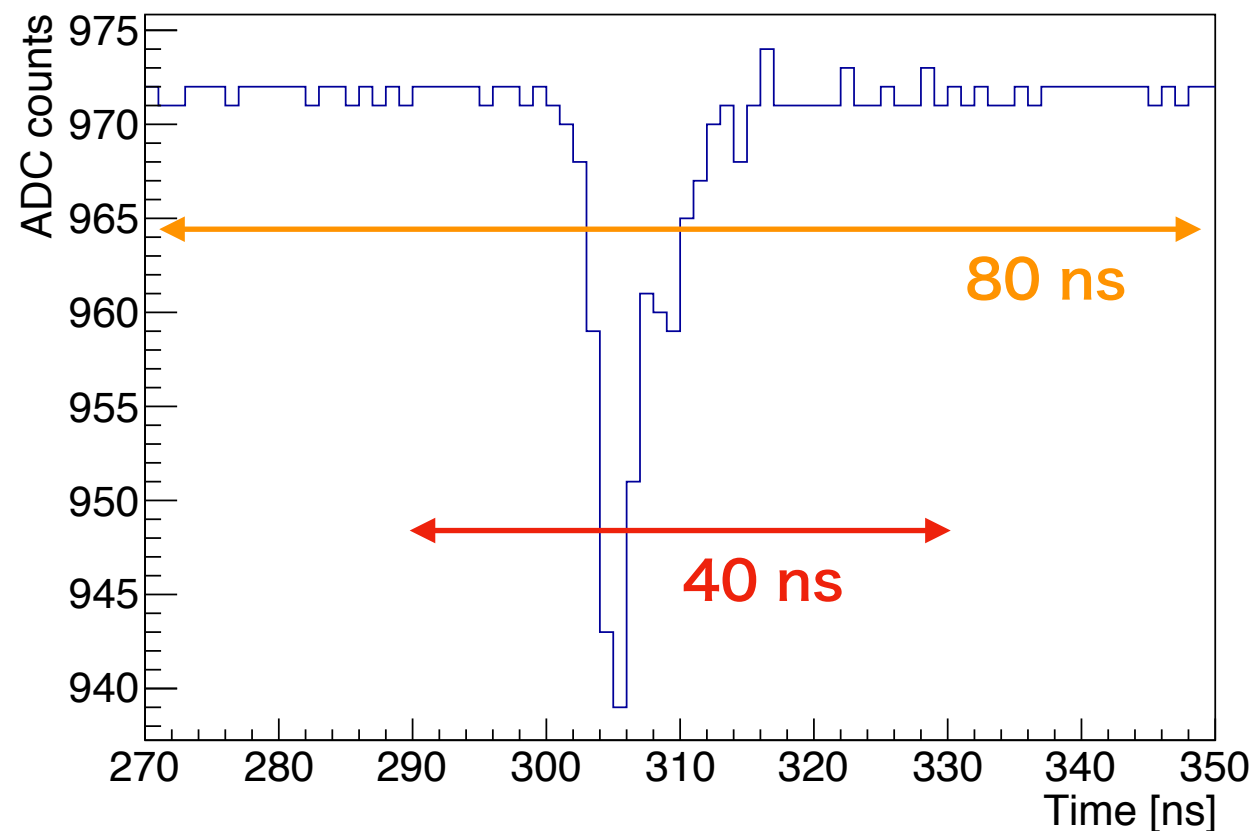
## Signals of 3-inch PMT

- I changed the integration range from 80 ns to 40 ns.
- This way made the peak clearer.
