Status Report: at MEMPHYNO

Inomonoto, Sashima and Izumiyama 6 Mar. 2020 mPMT-Japan meeting

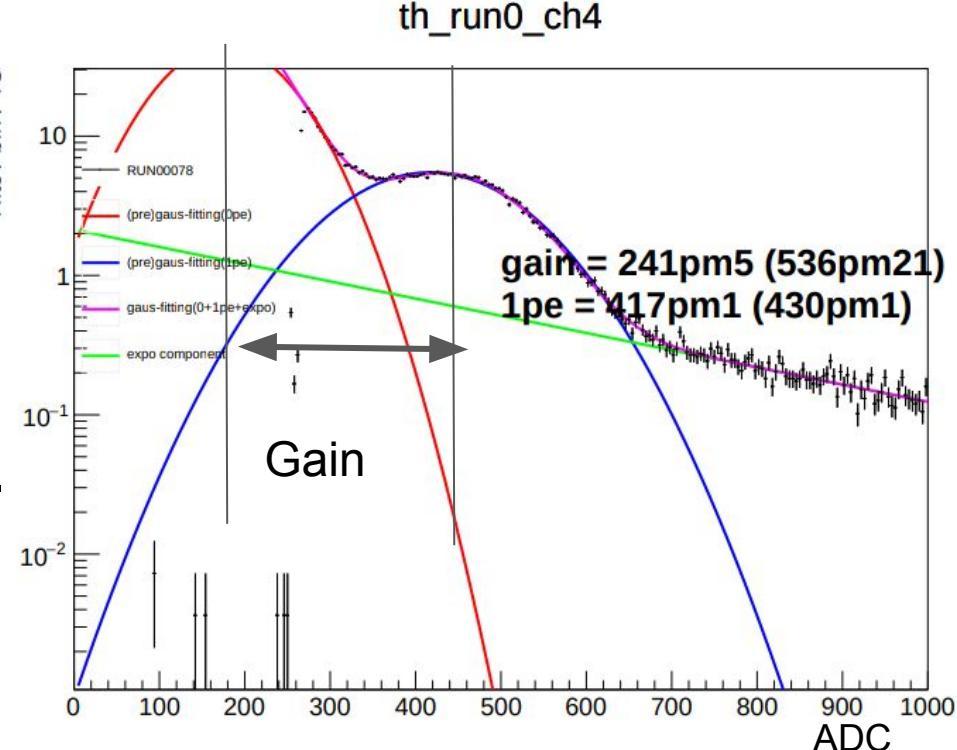
Fitter development

- Developed the fitter to calculate gain (ped. and 1 pe position):
 - Used 3 component: ped. gaussian, 1pe gaussian and exp. curve 0
 - 1. Fit the shoulder and the peak with only one gaussian for each region (red / blue)
 - 2. Using the 1st result, fit with 3 components in region of [second bin from maximum bin, 1000.] (pink and green)
- Gain and 1pe position are shown in the plots
 - The values are calculated 0 with red and blue gauusian
 - Hits / bin / TS The values between "()" are 0 calculated by the result of fitting with 3 components
- Two are not consistent: difficulty of fitting of the ped.
 - \rightarrow Decided to align the 1pe positions for ch. by ch.

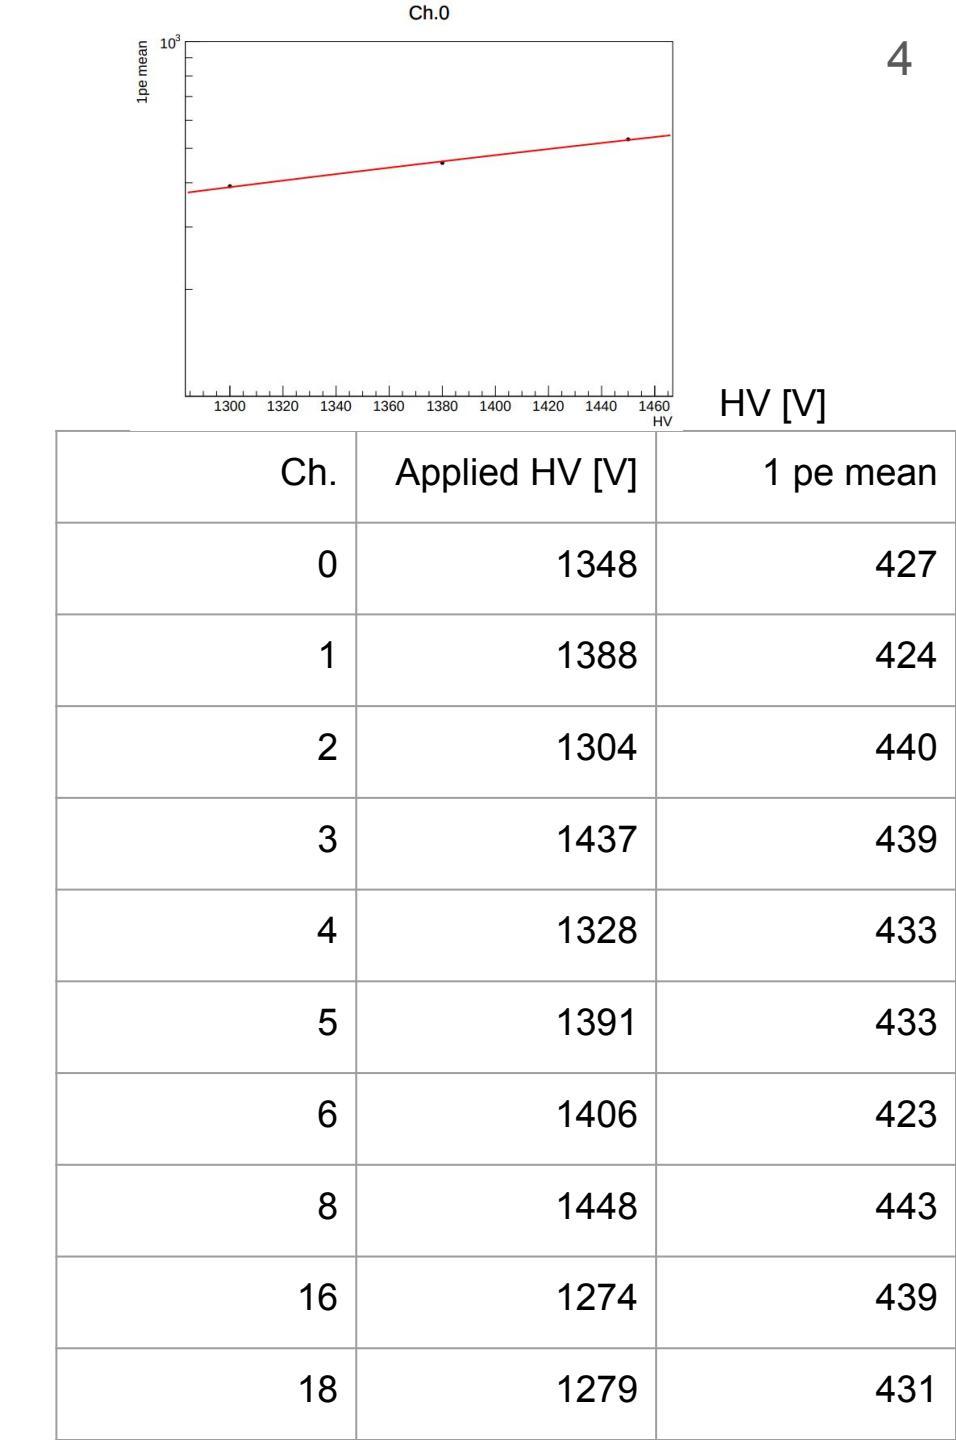
Gain tuning

- Took data with 3 different HVs:
 - 1300, V1 (different by ch.), 1450 [V]
- Plotted 1pe position
 Q vs HV and fitted with

- Estimated the proper HV for Q in order to be aligned for each ch.
 and applied estimated HV
 → 1 pe positions are aligned for all channels at
 - 430 within 15 precision

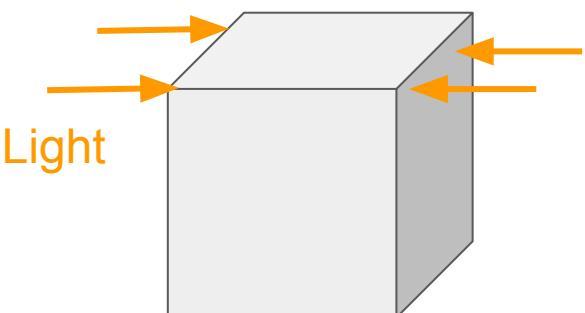
Light source directions

- At last HKPCM, the dark rate is correlated with day/night time → seems to be the light leakage
- Checking the light leakage point with light source.
 - Investigating the light leakage from the 4 corners of MEMPHYNO.
- Took the date, then we are analyzing it.
